**Mercers, Harlow, CM19 5PN**

# **Roof Condition Appraisal Report**

Harlow Property Services,  
Harlow District Council

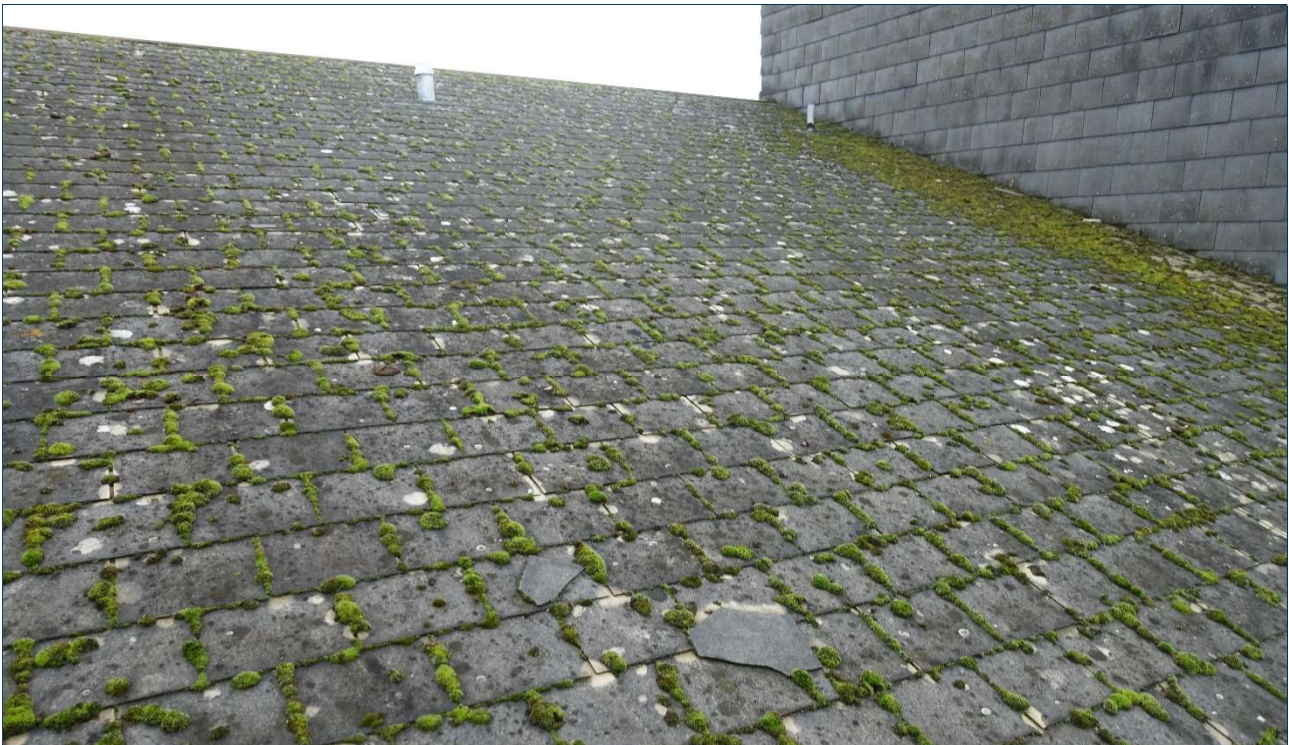
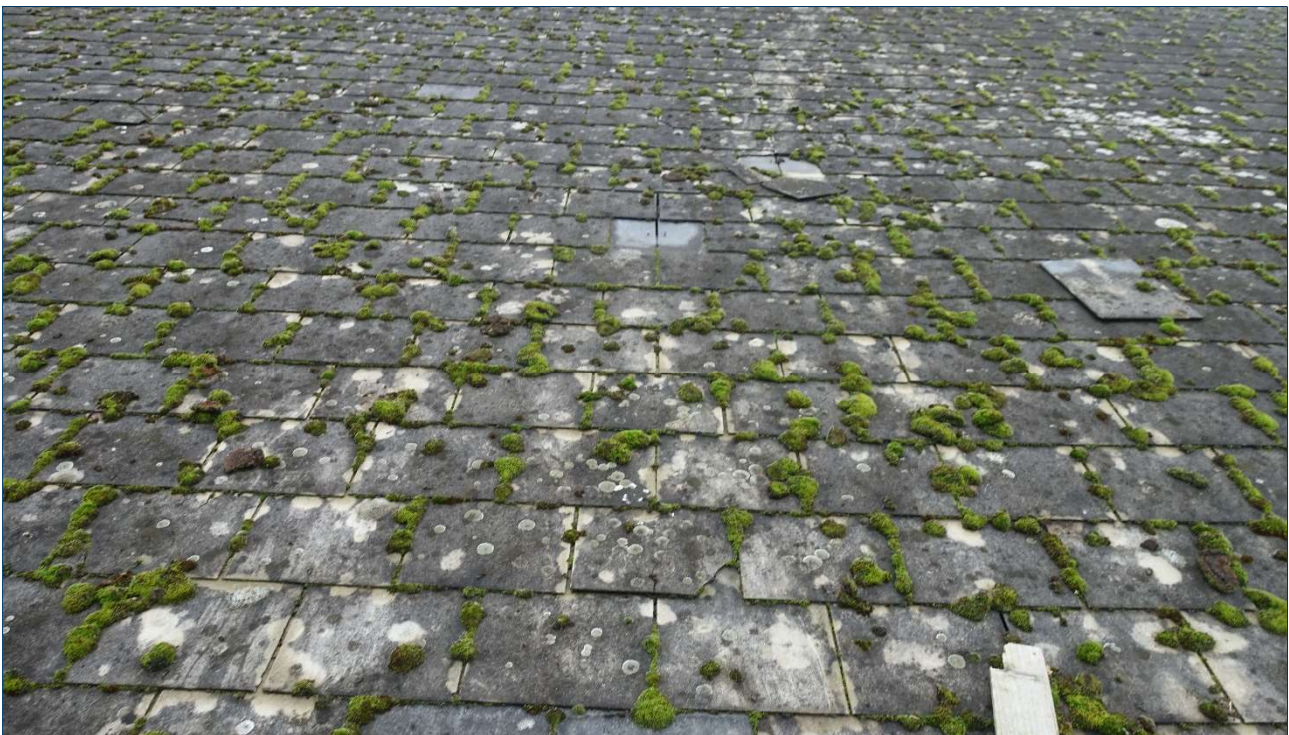
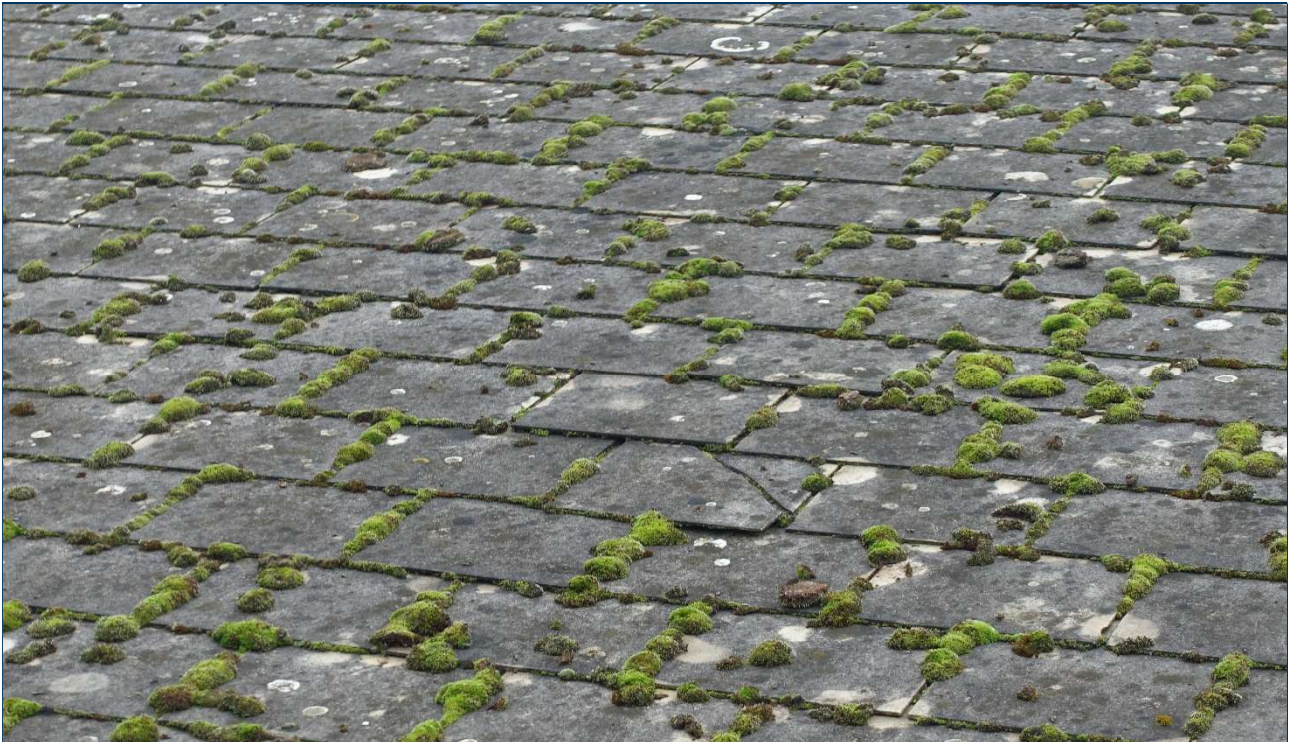
Photo 01 Mono-Pitch Roof

As noted, the cement based asbestos tiles are generally in a poor condition as evidenced by Photograph No.01 – No.5. It appears that many of these tiles have become brittle and have deteriorated, leading to cracking and dislodgement of tiles observed.

We also note significant moss and lichen growth to these roof areas, refer to Photograph No.01 – No.05. This can more easily occur when the surface of the cement tiles starts to delaminate accelerating the build-up of moss which will further slowdown surface water run-off. The moss can also lead to blocked gutters which will reduce and slow rainwater dispersal, increasing the risk of wind driven rain penetrating under lapped tile courses or moisture being drawn under the tiles by capillary action and the moss build up and congested of gutters and down pipes could lead to gutters over flowing. This could lead to issues of water tracking back into the cavity, as evidenced by water ingress issues to a ground floor flat.

The ongoing tile failure and presence of asbestos containing material, suggest that the roofs should be replaced in their entirety.

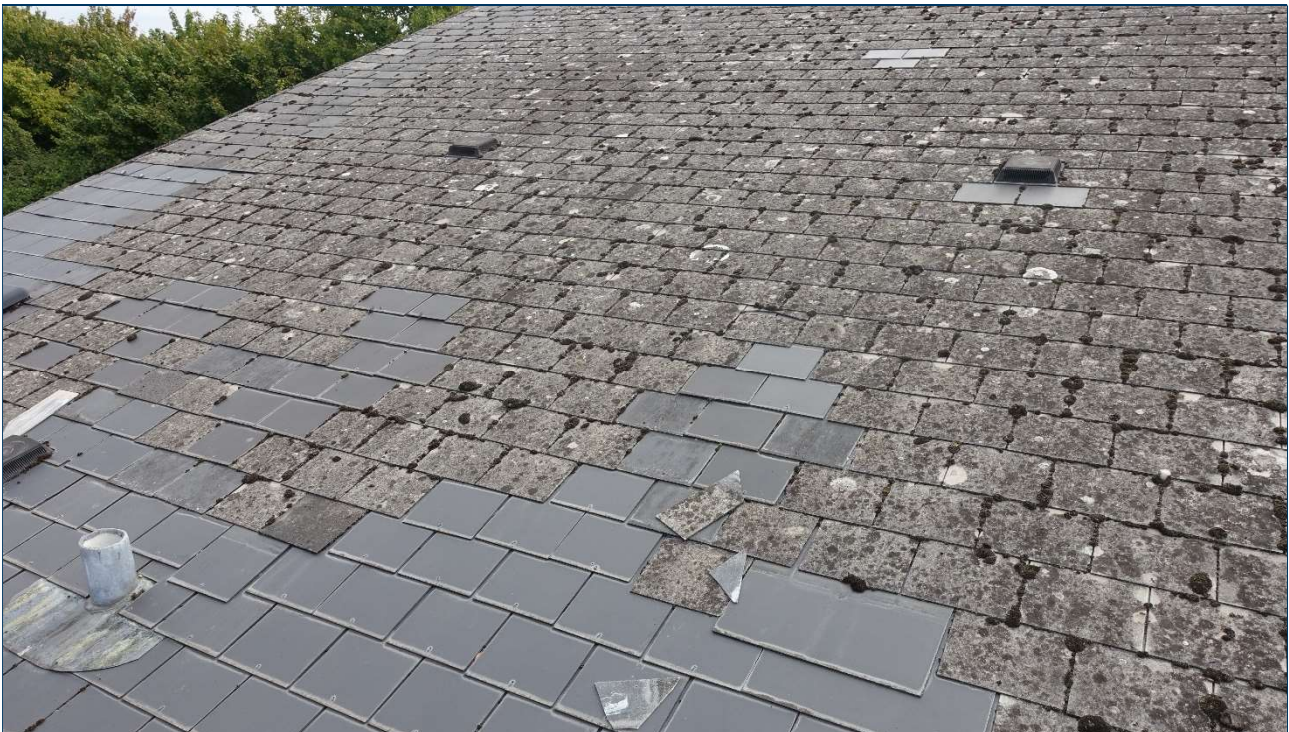
Photo 04 Mono-Pitch Roof

During our inspection, we observed that in isolated areas, roof vents have been installed, refer to Photograph No.04. It is not clear why isolated areas have roof vents, although we suspect that excessive moisture conditions within this particular roof void was addressed as a repair method.

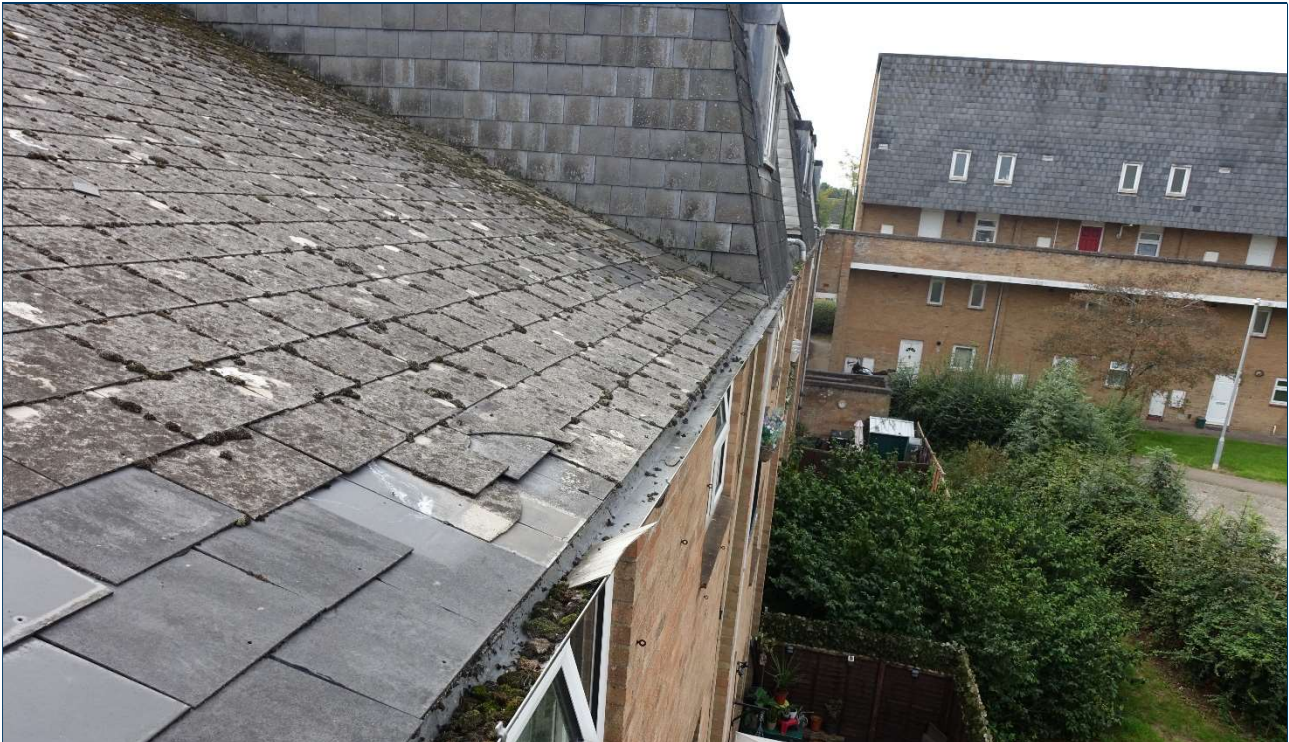
We observed a damaged and dislodged tile, which had fallen into the gutter, as well as debris blocking the gutter, refer to Photograph No.05. This particular issue is causing water ingress into the cavity where it can percolate down between the brick leaf's, where it meets the obstruction

caused by the cavity tray and can then be seen emanating from above and around opening of the ground floor flat below.

The rainwater gutter in this location also does not seem to have a sufficient fall towards the downpipe to the right-hand side. This issue is compounded by the congested gutter and will be exacerbating the problem further, allowing rainwater to overflow, possibly allowing it to enter the cavity if this has not been closed off correctly at the roof plate level.

Photo 05 Mono-Pitch Roof – Debris / Tile in Gutter

- Replace all rainwater goods, laid to correct falls.
- Install new all cladding system, with new cross batten arrangement, including breathable membrane and ventilation.

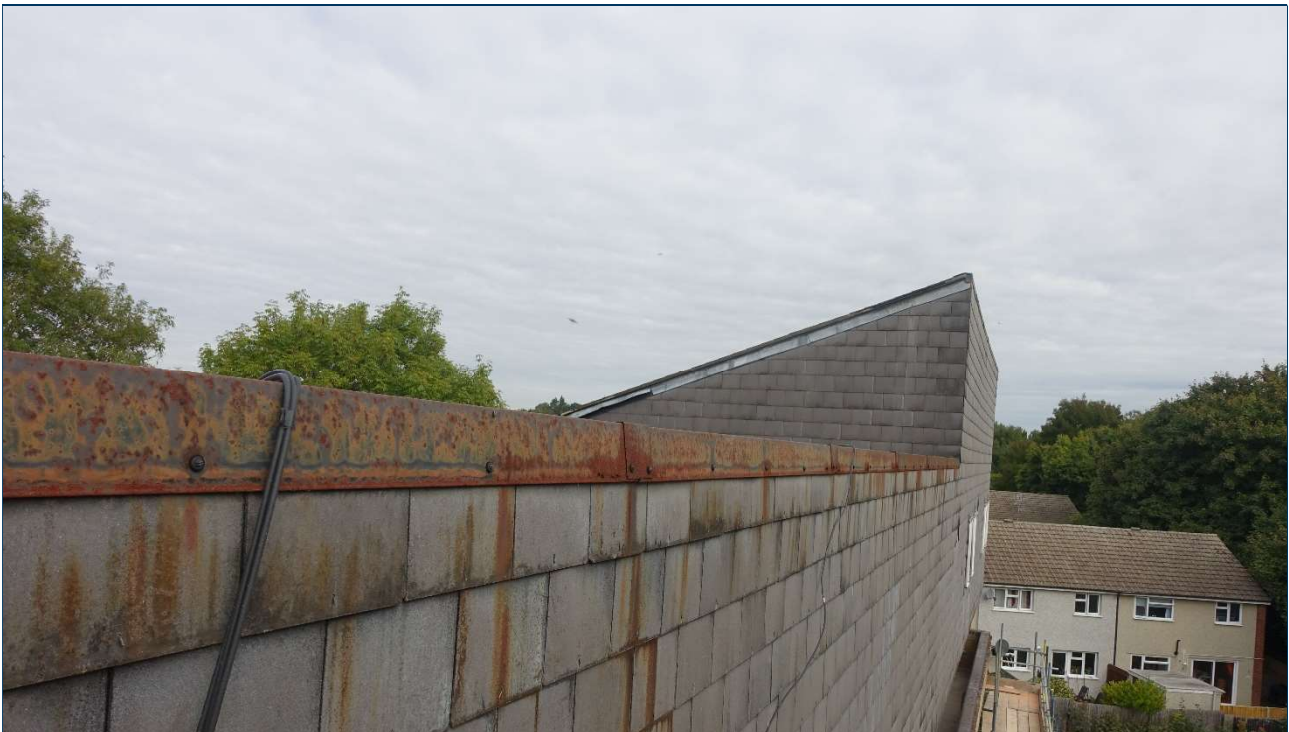
To the top of the mono-pitched roofs, there are roof cap flashings installed. We observed that the cap flashings are heavily corroded, as shown in Photograph No.06. Corrosive staining can be seen below this capping. We have not confirmed what the pressed sheet metal capping material is, although noted it is heavily corroded in places.

The cap flashing is poorly installed, with the cappings but jointed together, with a small section of capping over the junction. The overlaid capping piece of the butt joint is approximately 100mm wide, which is insufficient for deflecting water away from the capping and will permit water to enter the roof void and the cladded wall sections. We overserve that this issue could be contributing to water entry into the cavity, although this was not verified.

Photo 06 Adjacent Mono-Pitch Roof – Cap Flashings

Regardless of the poor overlap, the capping details are in very poor condition and will need to be replaced throughout the estate.

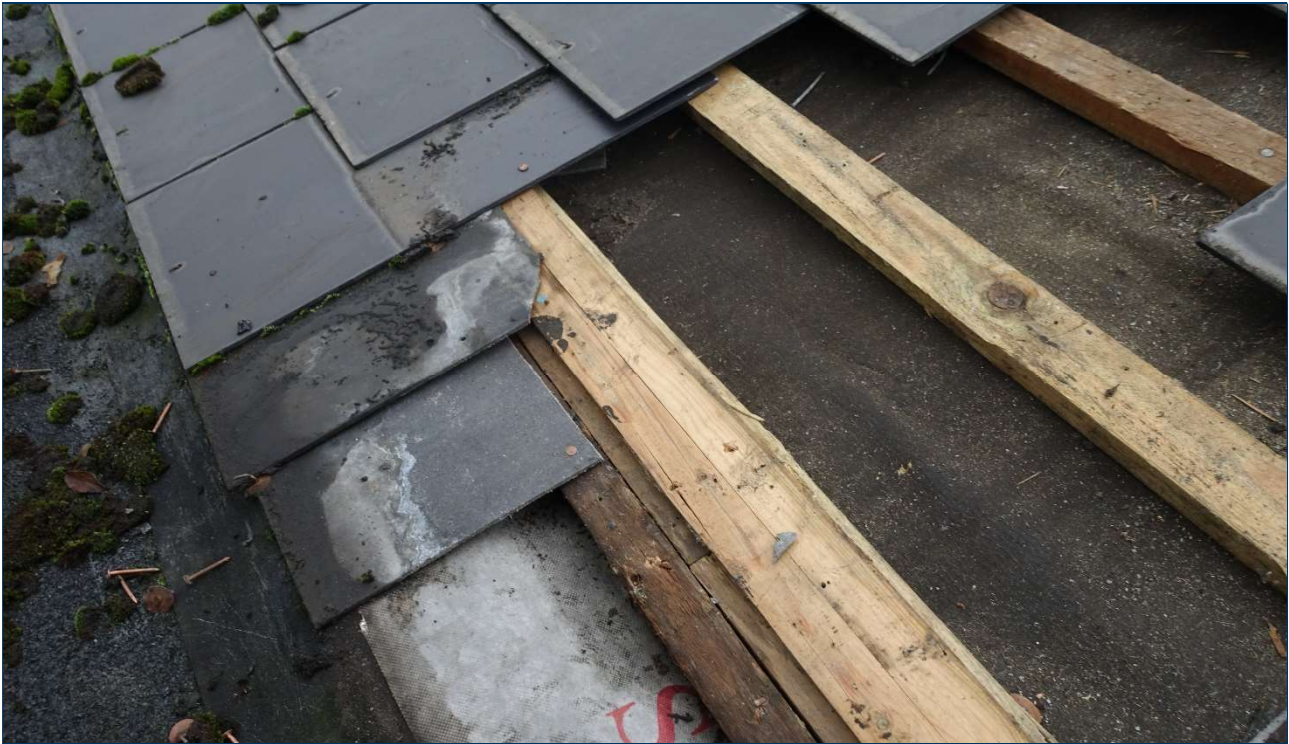
Once lifted, we observed that a series of horizontal roof battens installed, in particular a row of three horizontal battens is installed along the sarking detail, where it meets the felt flat roof. As shown in Photograph No.07, there are no cross battens installed on this roof, therefore preventing water to flow across the felt surface and any water that may have percolated the tiles is becoming trapped at this location where the felt is not perforated. Timber decay was noted to the horizontal battens in this location which verifies that water is penetrating the underside of the tiles, refer to Photograph No.07 & No.09. It is also understood that water laying on the flat roof is tracking its way back towards the pitched roof, adding to the issues

As noted above, a number many tiles have been replaced with a more modern, non-asbestos tile and particularly at low level, where the pitched and flat roofs intersect. As shown in Photograph No.07, it appears that an additional breathable membrane underlay has been installed, likely to supplement the previously failed felt underlay material when partial replacement tiles were re-laid.

Photo 07 Flat Roof to Pitched Roof Detail

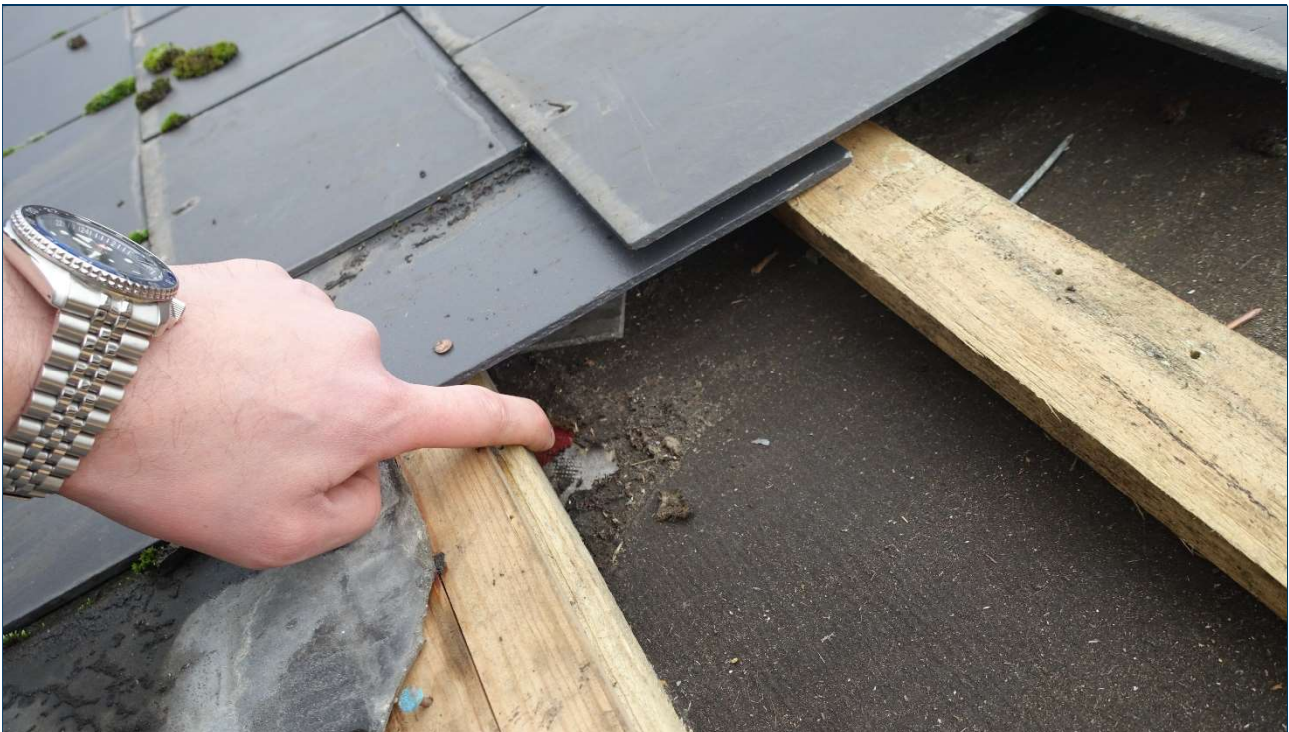
The exposed sarking detail revealed deterioration to the roof underlay, where it has become brittle and is damaged, with cracking and holes, refer to Photograph No.8. Excessive moisture can also be seen in this location, refer to Photograph No.09. We also observed in the area exposed, that the underlay has not been properly lapped, with a butt joint observed, refer to Photograph No.10.

Photo 08 Mono-Pitch Roof – Damage to Underlay

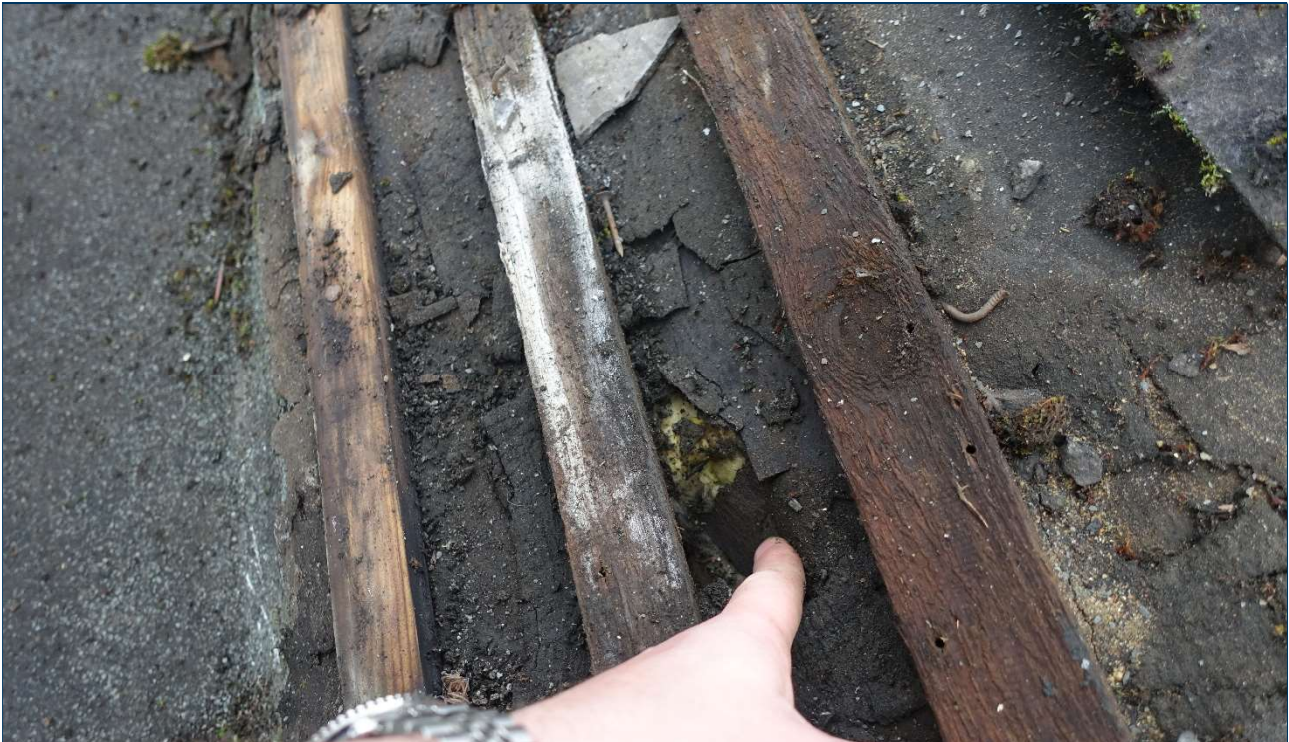
Photo 09 Mono-Pitch Roof – Damage to Underlay & Saturated / Decayed Battens

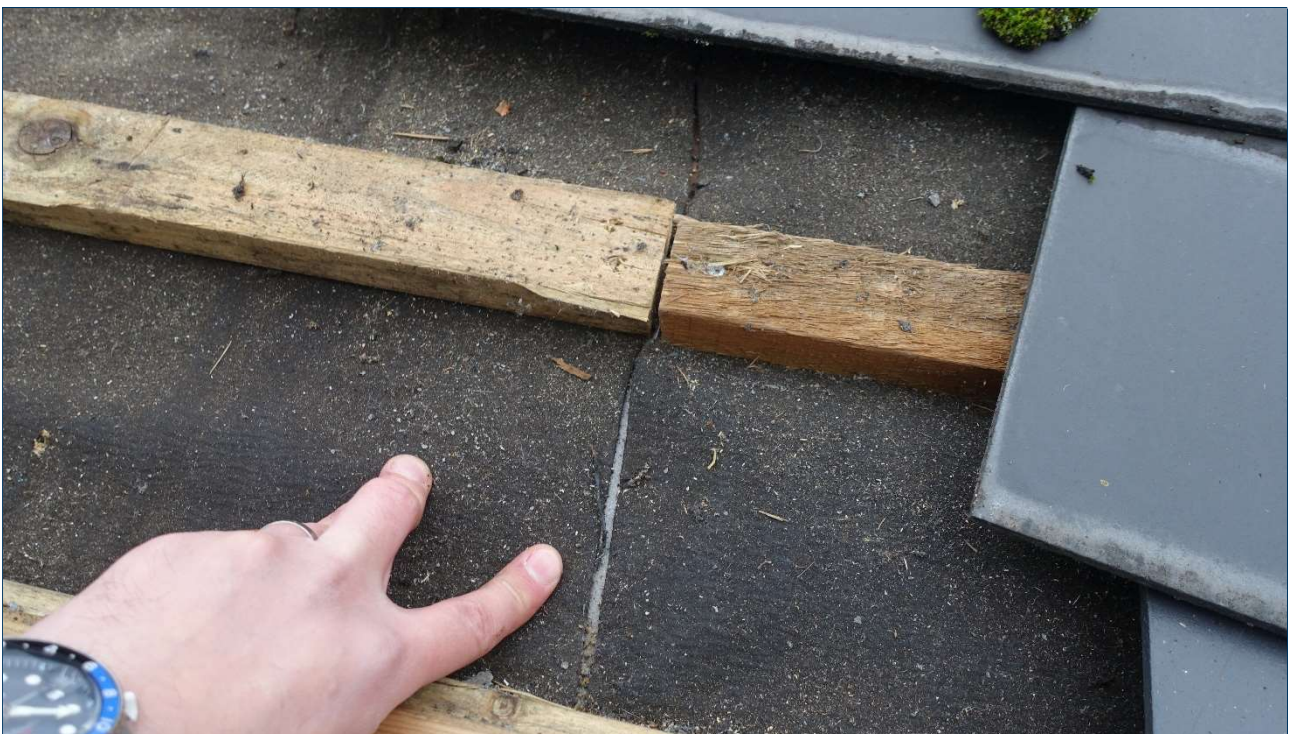
Photo 10 Mono-Pitch Roof – Underlay Butt Joint

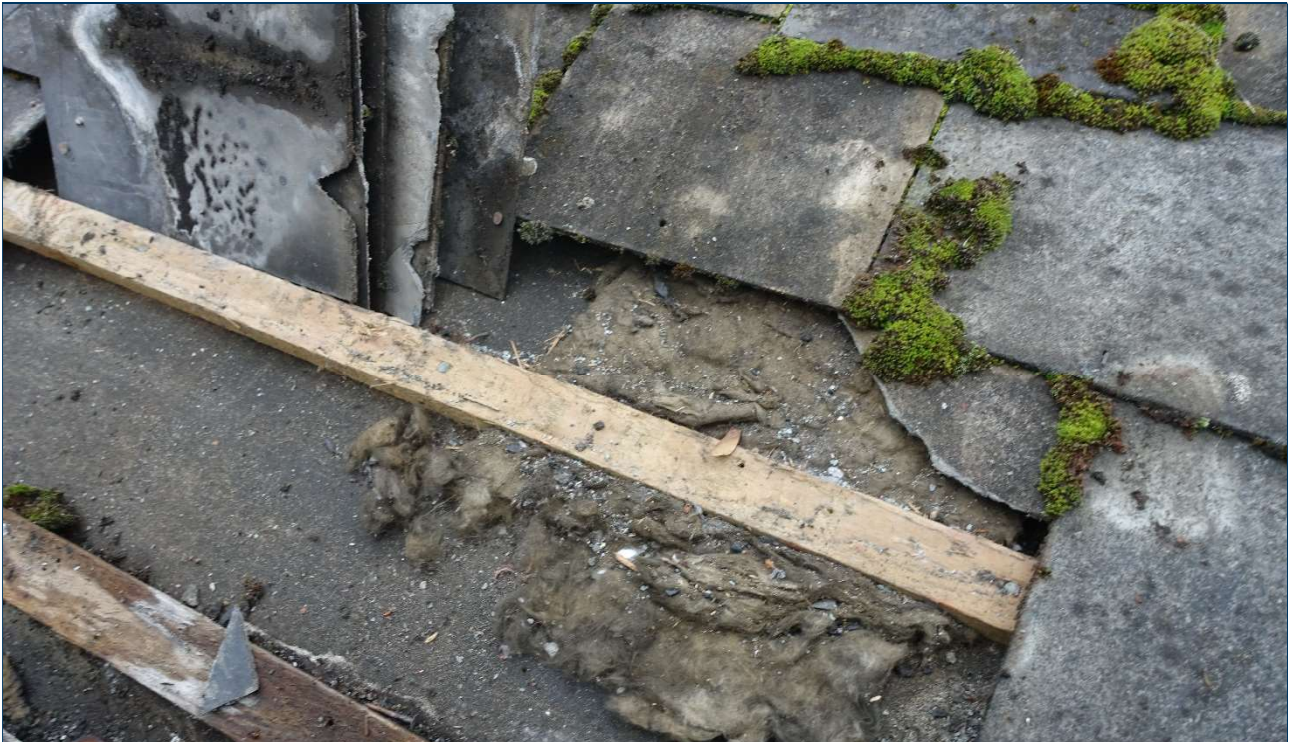
We further noted that an isolated area of loose rolled insulation material has been placed between battens, refer to Photograph No.11. It is unclear why this has been installed, although suspect it may be related to persons attempting to prevent roof tiles chattering in the wind. Roof chatter can be caused by wind and is common on lightweight tiled roofs.

Photo 11 Mono-Pitch Roof – Insulation Installed

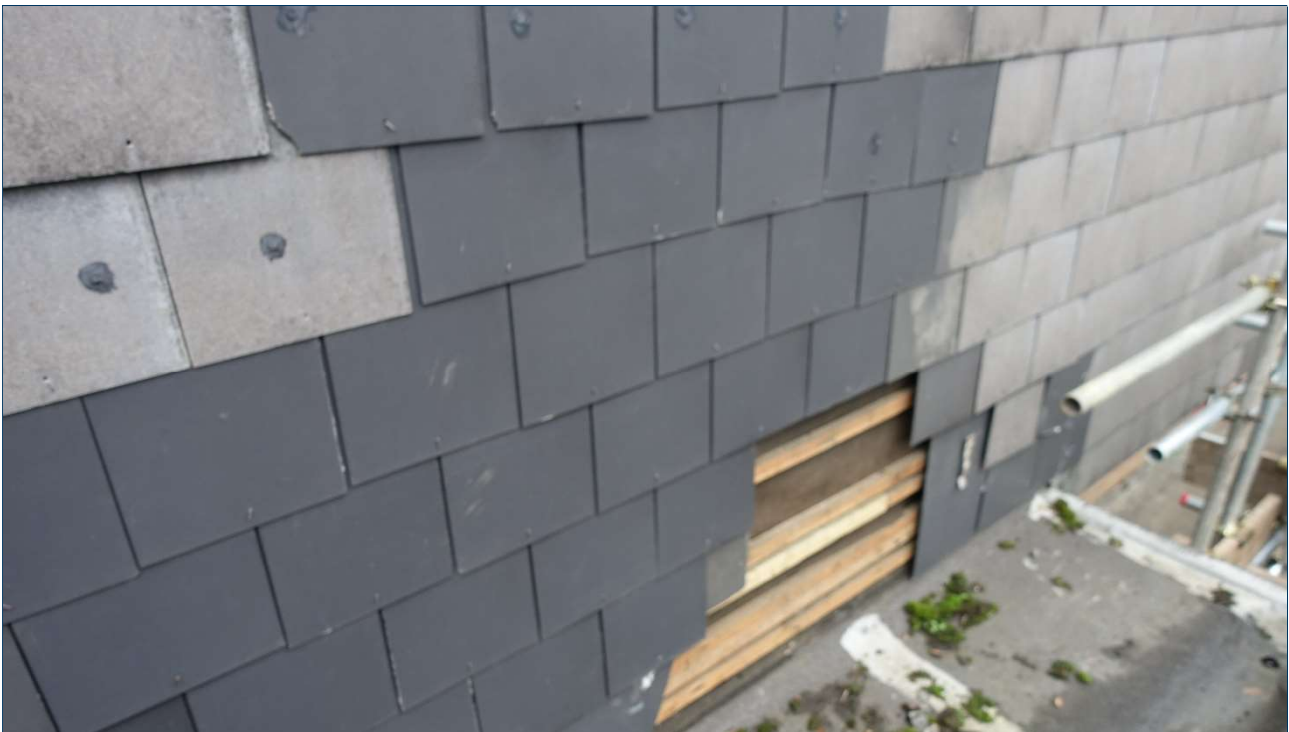
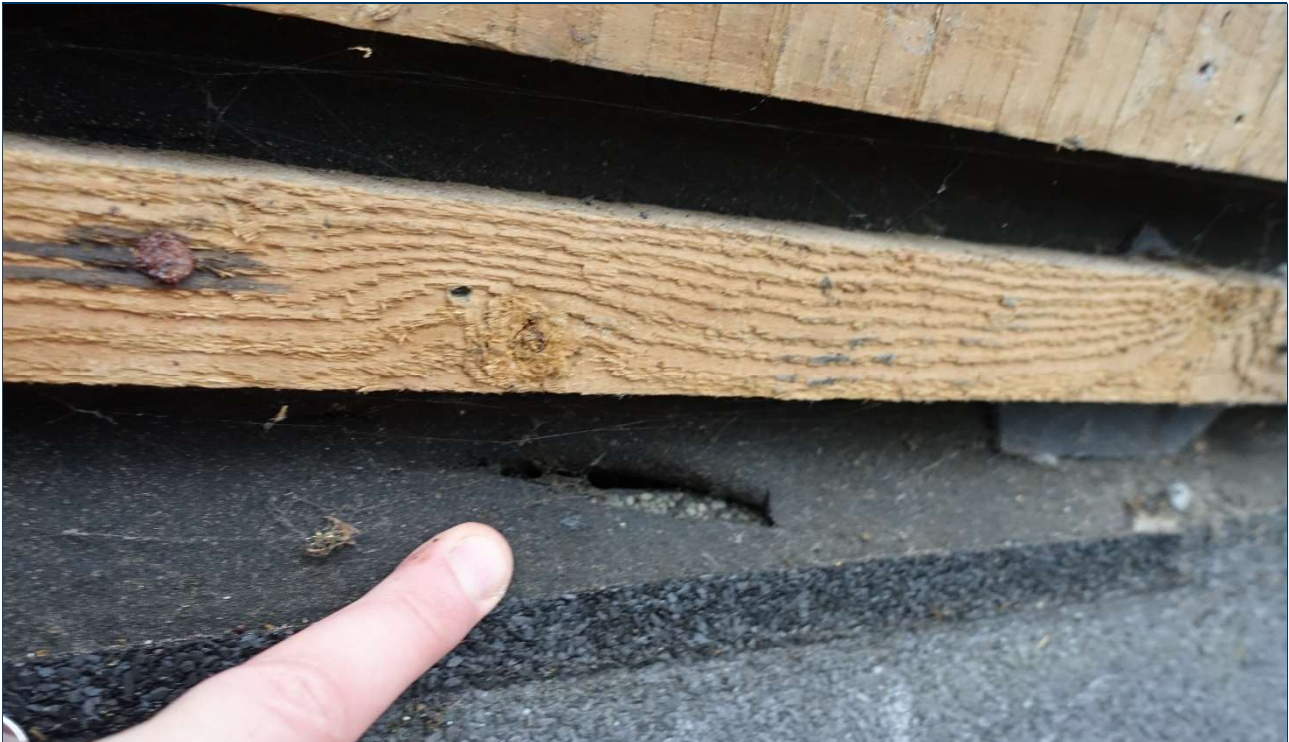
An area of cladding, where replaced previously with an artificial slate was lifted at the base of the wall, which revealed the upstanding level, refer to Photograph No.12 & No.13. As shown, there is a tear to the underlay in this location, which is at the junction of the upstanding section.

Refer to Photograph No.12 – No.13, showing the wall cladding arrangement, including the battens and membrane, in two locations inspected.

Photo 12 Vertical Wall Cladding – Area No.1 Exposed

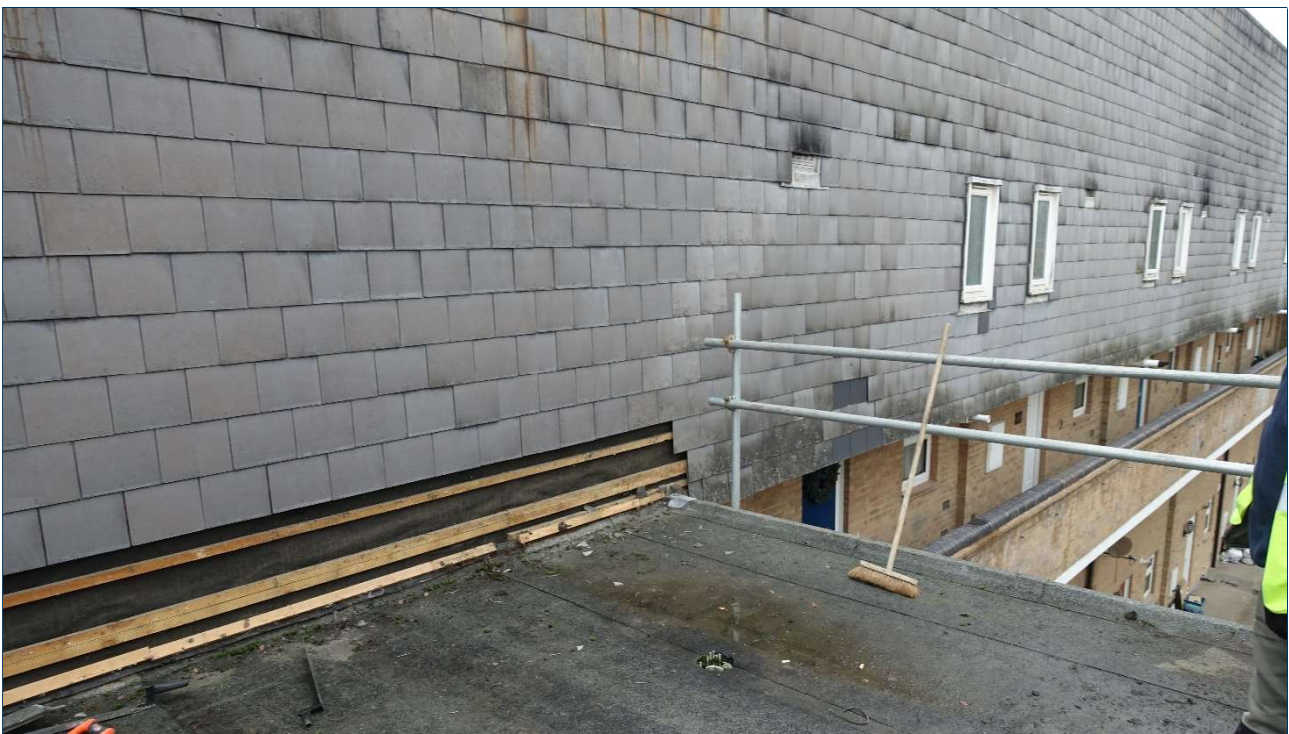
A further area was inspected, refer Photograph No.14. In this location, the upstanding detail was of a shallow height and not the minimum 150mm height, to be expected.

Photo 14 Vertical Wall Cladding – Area No.2 Exposed

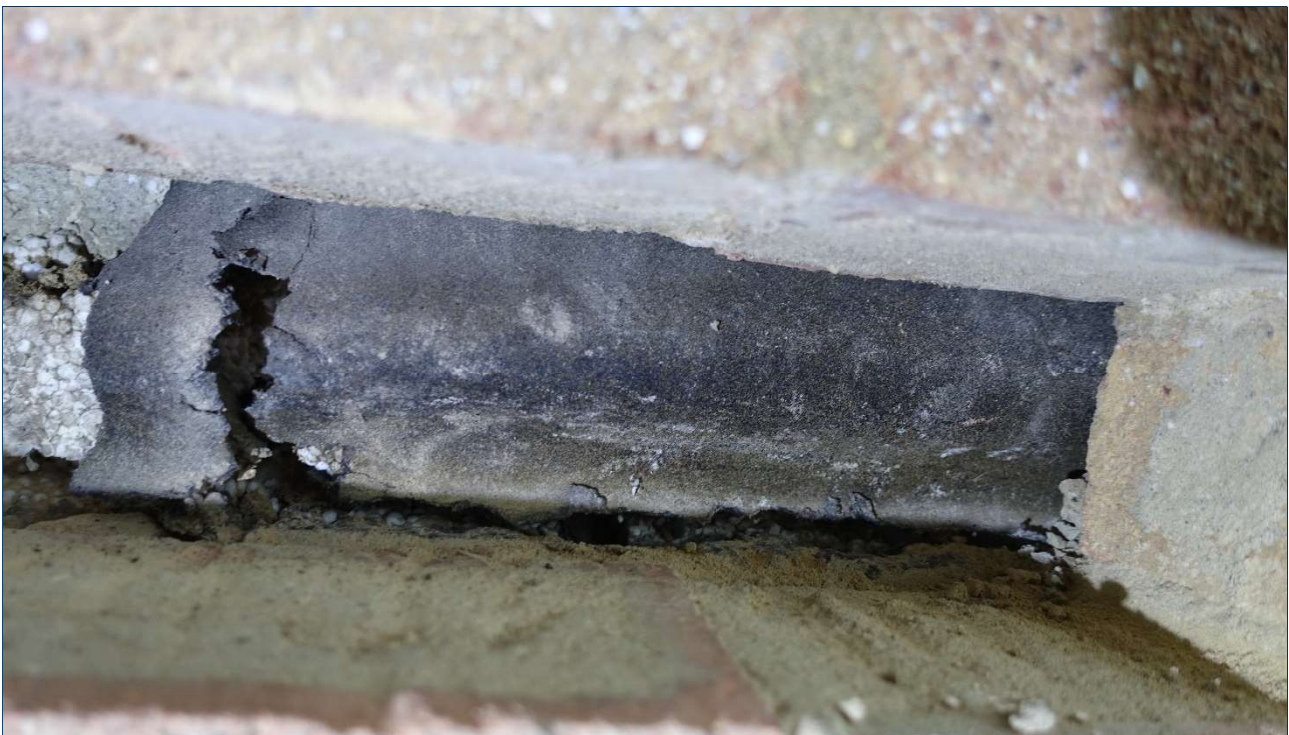
We also noted in the area inspected that the upstanding section of the cavity tray is torn, refer to Photograph No. 16. While we expect that a bitumen DPC can withstand thermal movement, it appears to have failed as it has become brittle with age or had been incorrectly and poorly installed. The cavity tray was noted to be torn in its entire visible depth, as demonstrated in Photograph No.18.

Photo 16 Window Head Detail – Bitumen Type DPC Cavity Tray

We recommend that this apparent and inherent defective detailing and or age-related deterioration of the DPC forming the cavity tray, is checked with a further two intrusive window head inspections, at randomly chosen sample locations. This will confirm the extent of these works and provide an understanding of the wider estate issues. However, due allowance to replace all cavity trays has been suggested from our limited inspections.

We therefore have suggested that all cavity trays are replaced, with a suitable tray having stop ends, with new weep vents above openings.

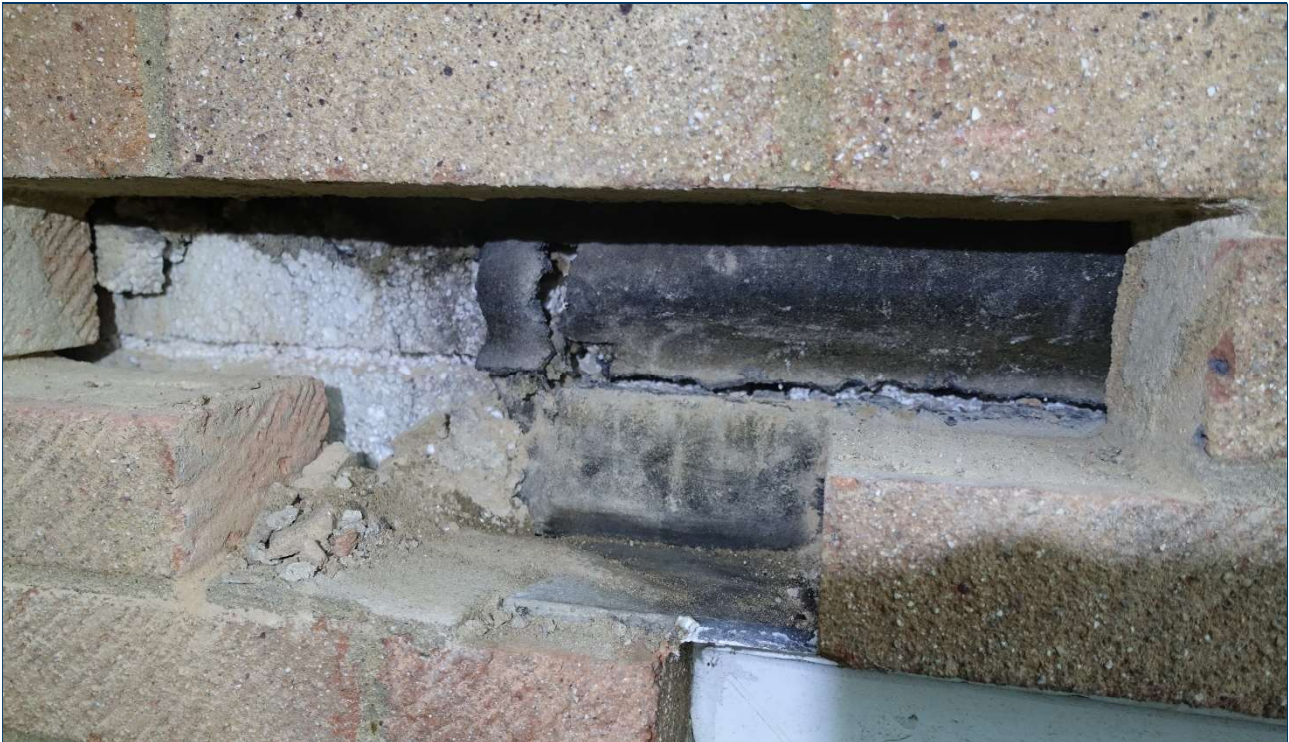
Photo 17 Window Head Detail – Bitumen Type DPC Cavity Tray without Stop End

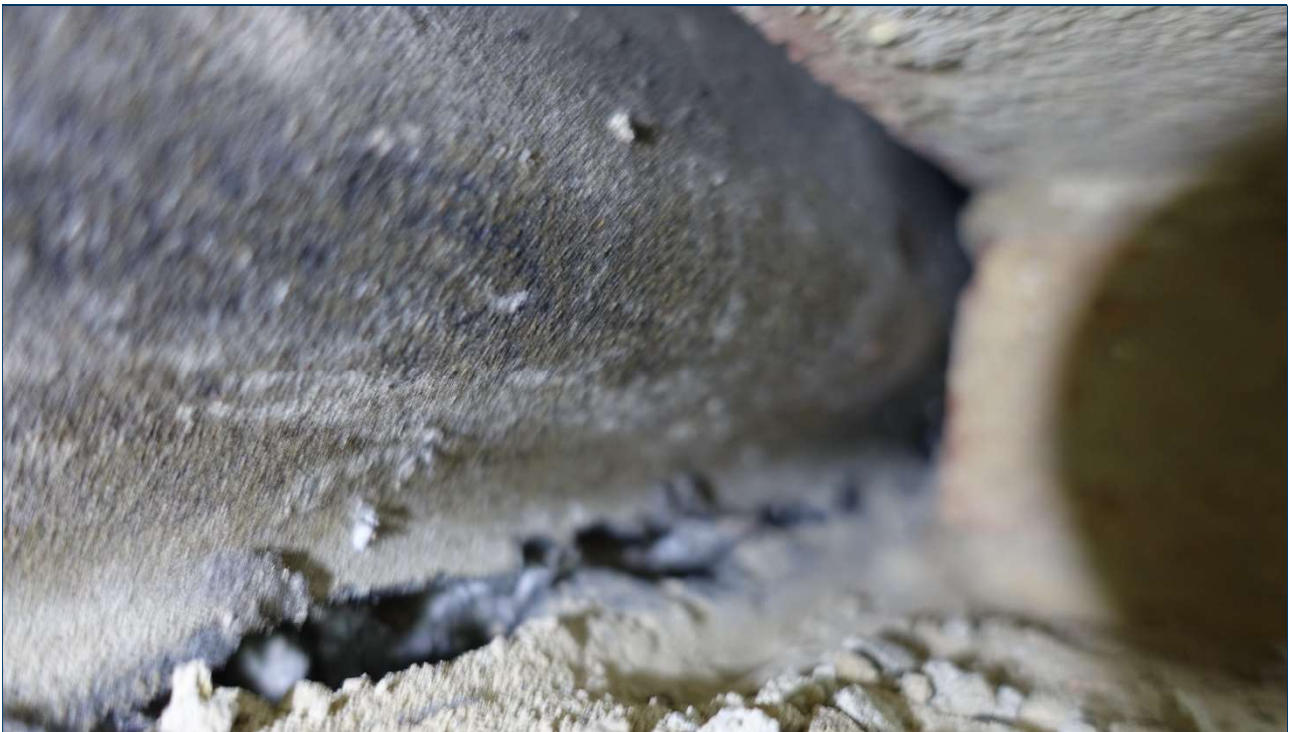
Photo 18 Window Head Detail – Bitumen Type DPC Cavity Tray
