ASBESTOS MANAGEMENT SURVEY

SURVEY REFERENCE NO. J006049

Flat Block 1-54 Mercers
Harlow
Essex
CM19 5PN

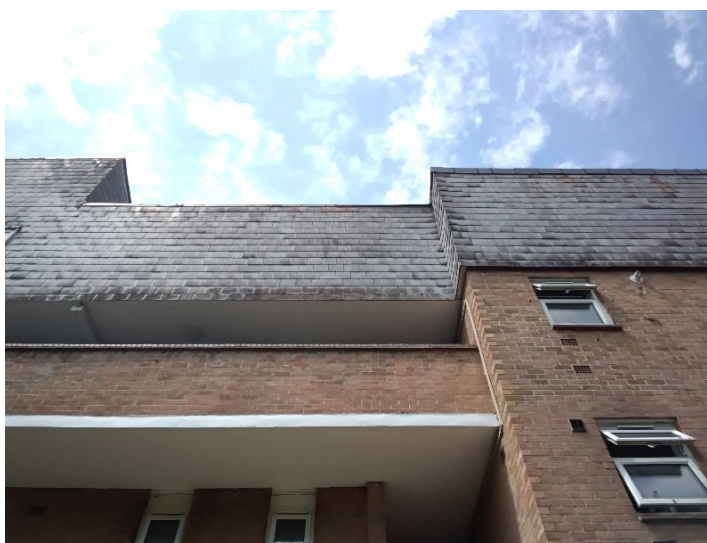
Site:	Flat Block 1-54 Mercers, Harlow, Essex, CM19 5PN
Inspection No:	22
Sample No:	CW000759
Asbestos Type:	Chrysotile
Floor Level:	External
Area:	Block 1-15
Location:	Cement tiles to high level facade and roof
Material Description:	Asbestos Cement
Approximate Quantity:	>200m ²
Accessibility:	Occasionally likely to be disturbed

Material Risk Assessment	Score
Product / Material Type	1
Condition / Damage	1
Surface Treatment	1
Asbestos Type	1
Material Assessment Score	4
Material Assessment Category	Low

Recommended Actions:
<p>Actions: Manage</p> <p>Comments:</p>

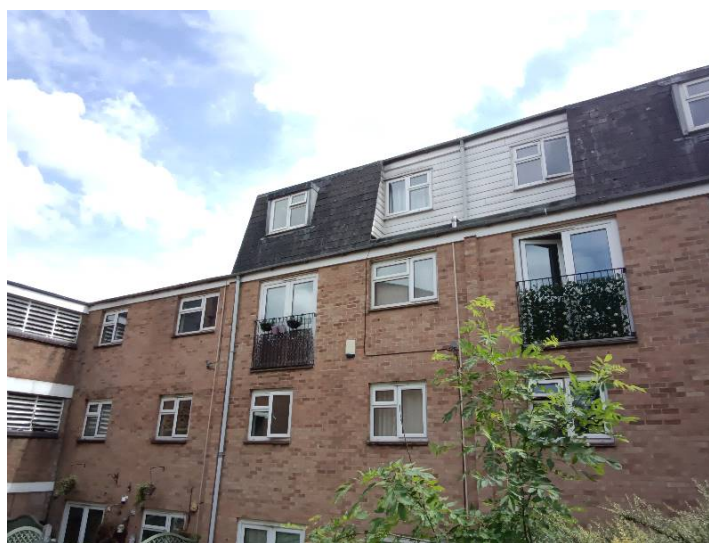
Site:	Flat Block 1-54 Mercers, Harlow, Essex, CM19 5PN
Inspection No:	23
Sample No:	CW000760
Asbestos Type:	Chrysotile
Floor Level:	External
Area:	Block 1-15
Location:	Cement tiles to high level facade and roof
Material Description:	Asbestos Cement
Approximate Quantity:	>200m ²
Accessibility:	Occasionally likely to be disturbed

Material Risk Assessment	Score
Product / Material Type	1
Condition / Damage	1
Surface Treatment	1
Asbestos Type	1
Material Assessment Score	4
Material Assessment Category	Low

Recommended Actions:
<p>Actions: Manage</p> <p>Comments:</p>

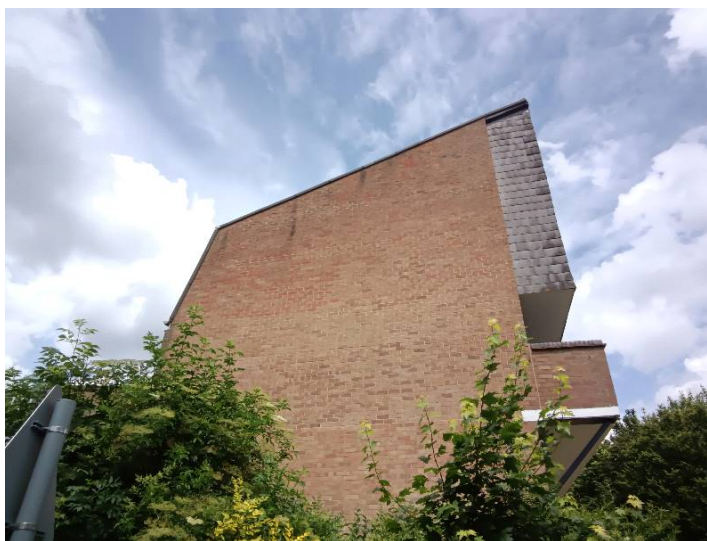
Site:	Flat Block 1-54 Mercers, Harlow, Essex, CM19 5PN
Inspection No:	24
Sample No:	As CW000760
Asbestos Type:	Chrysotile
Floor Level:	External
Area:	Block 1-15
Location:	Cement capping to pitched roofline
Material Description:	Asbestos Cement
Approximate Quantity:	11m ²
Accessibility:	Occasionally likely to be disturbed

Material Risk Assessment	Score
Product / Material Type	1
Condition / Damage	1
Surface Treatment	1
Asbestos Type	1
Material Assessment Score	4
Material Assessment Category	Low

Recommended Actions:
<p>Actions: Manage</p> <p>Comments:</p>

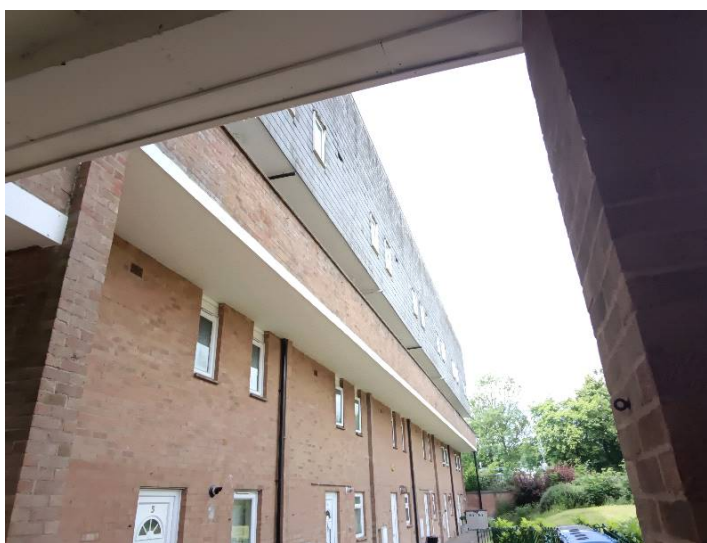
Site:	Flat Block 1-54 Mercers, Harlow, Essex, CM19 5PN
Inspection No:	25
Sample No:	As CW000759
Asbestos Type:	Chrysotile
Floor Level:	External
Area:	Block 5-21
Location:	Cement tiles to high level facade and roof
Material Description:	Asbestos Cement
Approximate Quantity:	>200m ²
Accessibility:	Occasionally likely to be disturbed

Material Risk Assessment	Score
Product / Material Type	1
Condition / Damage	1
Surface Treatment	1
Asbestos Type	1
Material Assessment Score	4
Material Assessment Category	Low

Recommended Actions:
<p>Actions: Manage</p> <p>Comments:</p>

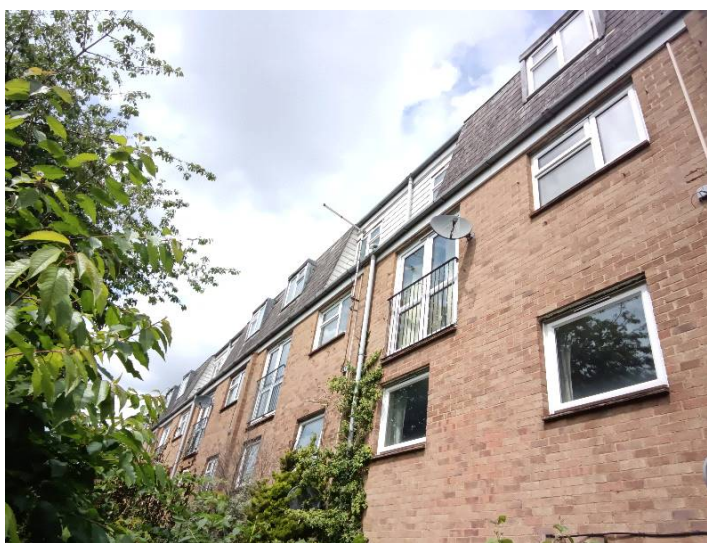
Site:	Flat Block 1-54 Mercers, Harlow, Essex, CM19 5PN
Inspection No:	26
Sample No:	As CW000760
Asbestos Type:	Chrysotile
Floor Level:	External
Area:	Block 5-21
Location:	Cement tiles to high level facade and roof
Material Description:	Asbestos Cement
Approximate Quantity:	>200m ²
Accessibility:	Occasionally likely to be disturbed

Material Risk Assessment	Score
Product / Material Type	1
Condition / Damage	1
Surface Treatment	1
Asbestos Type	1
Material Assessment Score	4
Material Assessment Category	Low

Recommended Actions:
<p>Actions: Manage</p> <p>Comments:</p>

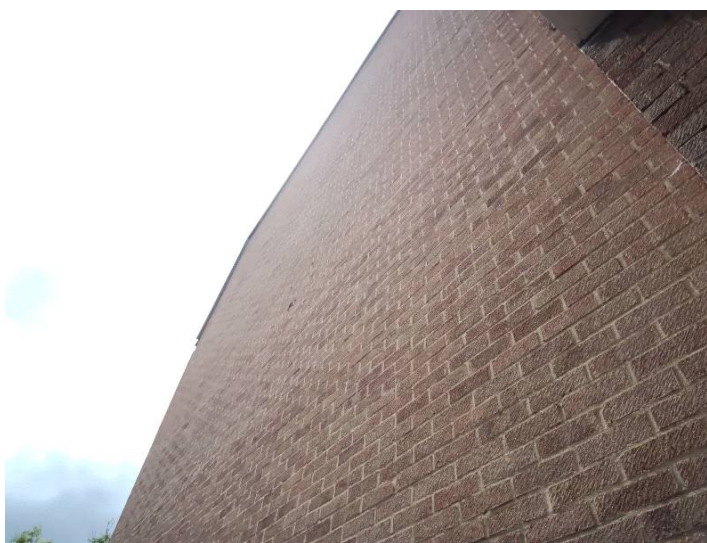
Site:	Flat Block 1-54 Mercers, Harlow, Essex, CM19 5PN
Inspection No:	27
Sample No:	As CW000760
Asbestos Type:	Chrysotile
Floor Level:	External
Area:	Block 5-21
Location:	Presumed cement capping to pitched roofline
Material Description:	Asbestos Cement
Approximate Quantity:	22lm
Accessibility:	Occasionally likely to be disturbed

Material Risk Assessment	Score
Product / Material Type	1
Condition / Damage	1
Surface Treatment	1
Asbestos Type	1
Material Assessment Score	4
Material Assessment Category	Low

Recommended Actions:
<p>Actions: Manage</p> <p>Comments:</p>

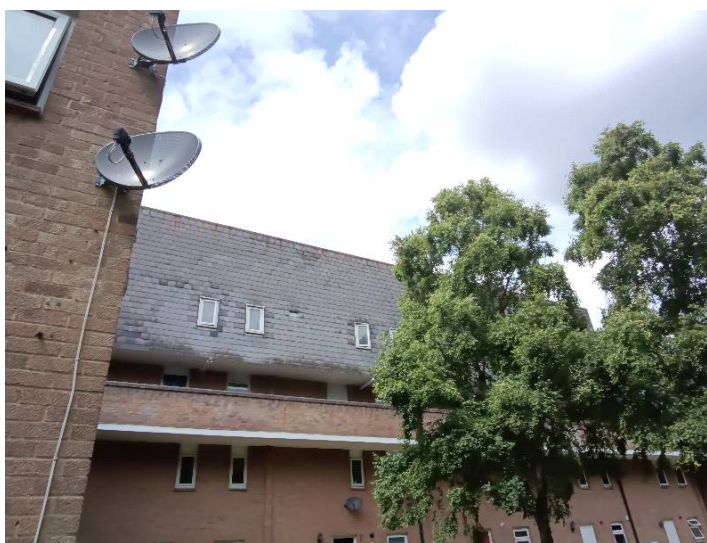
Site:	Flat Block 1-54 Mercers, Harlow, Essex, CM19 5PN
Inspection No:	28
Sample No:	CW000761
Asbestos Type:	Chrysotile
Floor Level:	External
Area:	Block 22-54
Location:	Cement roof tiles to high level facade and roof
Material Description:	Asbestos Cement
Approximate Quantity:	>200m ²
Accessibility:	Occasionally likely to be disturbed

Material Risk Assessment	Score
Product / Material Type	1
Condition / Damage	1
Surface Treatment	1
Asbestos Type	1
Material Assessment Score	4
Material Assessment Category	Low

Recommended Actions:
<p>Actions: Manage</p> <p>Comments:</p>

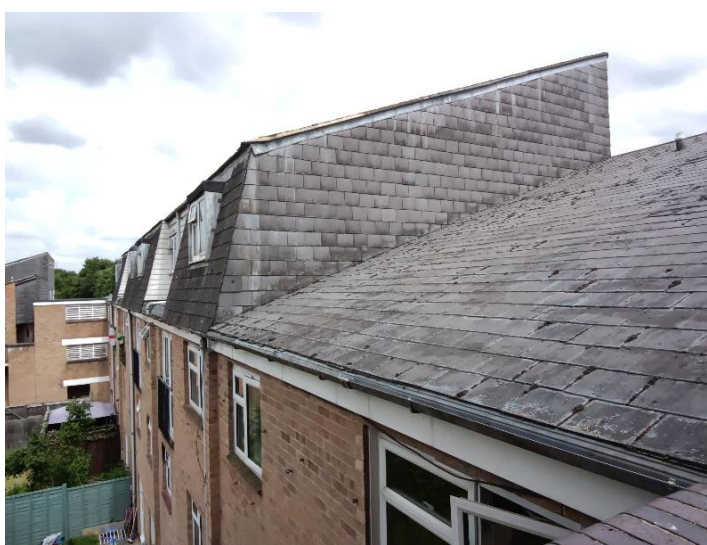
Site:	Flat Block 1-54 Mercers, Harlow, Essex, CM19 5PN
Inspection No:	29
Sample No:	CW000762
Asbestos Type:	Chrysotile
Floor Level:	External
Area:	Block 22-54
Location:	Cement roof tiles to high level roof and facade
Material Description:	Asbestos Cement
Approximate Quantity:	>200m ²
Accessibility:	Occasionally likely to be disturbed

Material Risk Assessment	Score
Product / Material Type	1
Condition / Damage	1
Surface Treatment	1
Asbestos Type	1
Material Assessment Score	4
Material Assessment Category	Low

Recommended Actions:
<p>Actions: Manage</p> <p>Comments:</p>

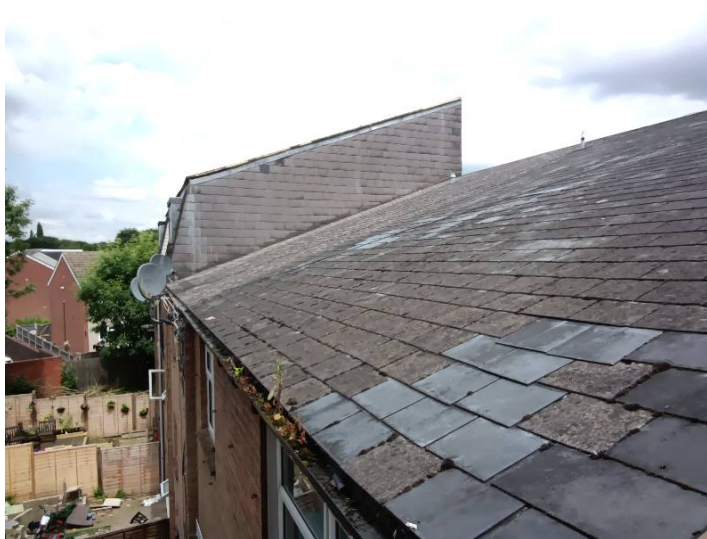
Site:	Flat Block 1-54 Mercers, Harlow, Essex, CM19 5PN
Inspection No:	31
Sample No:	As CW000761
Asbestos Type:	Chrysotile
Floor Level:	External
Area:	Block 29-42
Location:	Cement roof tiles to high level facade and roof
Material Description:	Asbestos Cement
Approximate Quantity:	>200m ²
Accessibility:	Occasionally likely to be disturbed

Material Risk Assessment	Score
Product / Material Type	1
Condition / Damage	1
Surface Treatment	1
Asbestos Type	1
Material Assessment Score	4
Material Assessment Category	Low

Recommended Actions:
<p>Actions: Manage</p> <p>Comments:</p>

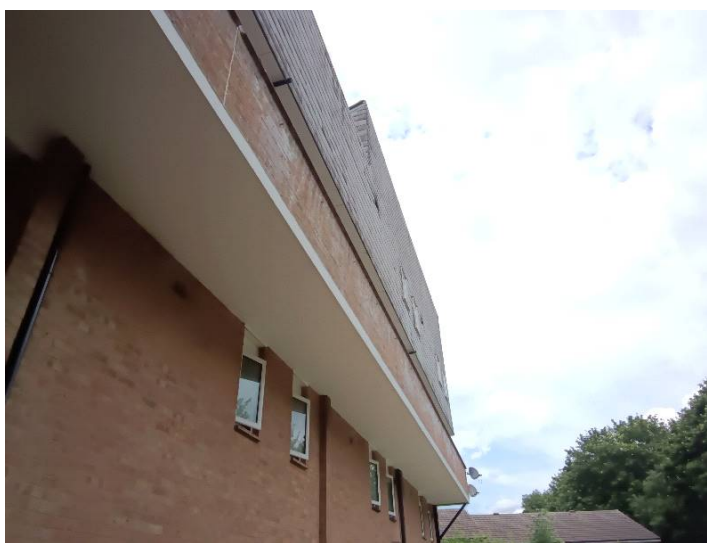
Site:	Flat Block 1-54 Mercers, Harlow, Essex, CM19 5PN
Inspection No:	32
Sample No:	As CW000762
Asbestos Type:	Chrysotile
Floor Level:	External
Area:	Block 29-42
Location:	Cement roof tiles to high level roof and facade
Material Description:	Asbestos Cement
Approximate Quantity:	>200m ²
Accessibility:	Occasionally likely to be disturbed

Material Risk Assessment	Score
Product / Material Type	1
Condition / Damage	1
Surface Treatment	1
Asbestos Type	1
Material Assessment Score	4
Material Assessment Category	Low

Recommended Actions:
<p>Actions: Manage</p> <p>Comments:</p>

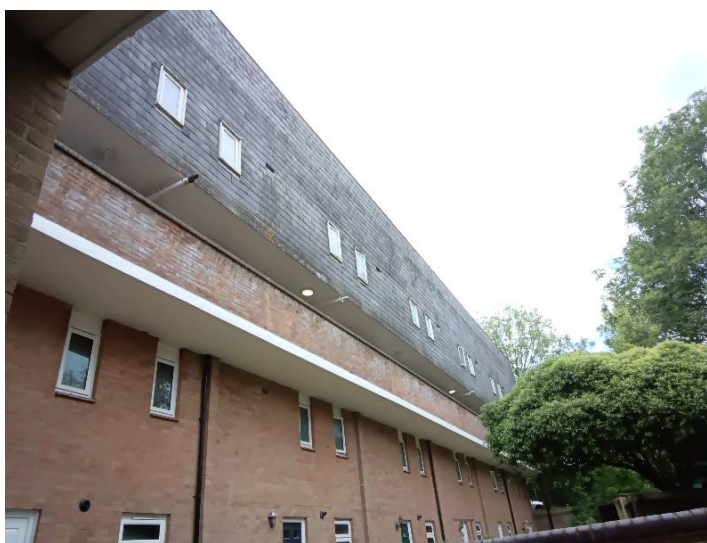
Site:	Flat Block 1-54 Mercers, Harlow, Essex, CM19 5PN
Inspection No:	34
Sample No:	As CW000761
Asbestos Type:	Chrysotile
Floor Level:	External
Area:	Block 33-48
Location:	Cement roof tiles to high level facade and roof
Material Description:	Asbestos Cement
Approximate Quantity:	>200m ²
Accessibility:	Occasionally likely to be disturbed

Material Risk Assessment	Score
Product / Material Type	1
Condition / Damage	1
Surface Treatment	1
Asbestos Type	1
Material Assessment Score	4
Material Assessment Category	Low

Recommended Actions:
<p>Actions: Manage</p> <p>Comments:</p>

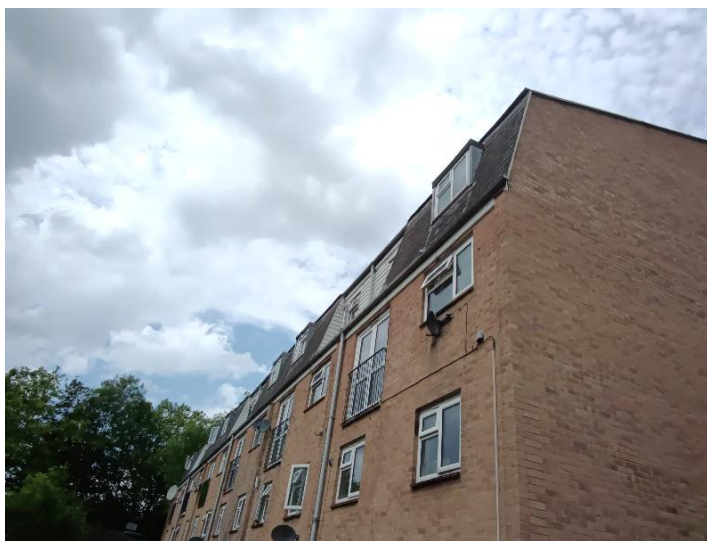
Site:	Flat Block 1-54 Mercers, Harlow, Essex, CM19 5PN
Inspection No:	35
Sample No:	As CW000762
Asbestos Type:	Chrysotile
Floor Level:	External
Area:	Block 33-48
Location:	Cement roof tiles to high level roof and facade
Material Description:	Asbestos Cement
Approximate Quantity:	>200m ²
Accessibility:	Occasionally likely to be disturbed

Material Risk Assessment	Score
Product / Material Type	1
Condition / Damage	1
Surface Treatment	1
Asbestos Type	1
Material Assessment Score	4
Material Assessment Category	Low

Recommended Actions:
<p>Actions: Manage</p> <p>Comments:</p>
