**Mercers, Harlow, CM19 5PN**

# **Roof Condition Appraisal Report**

Harlow Property Services,  
Harlow District Council

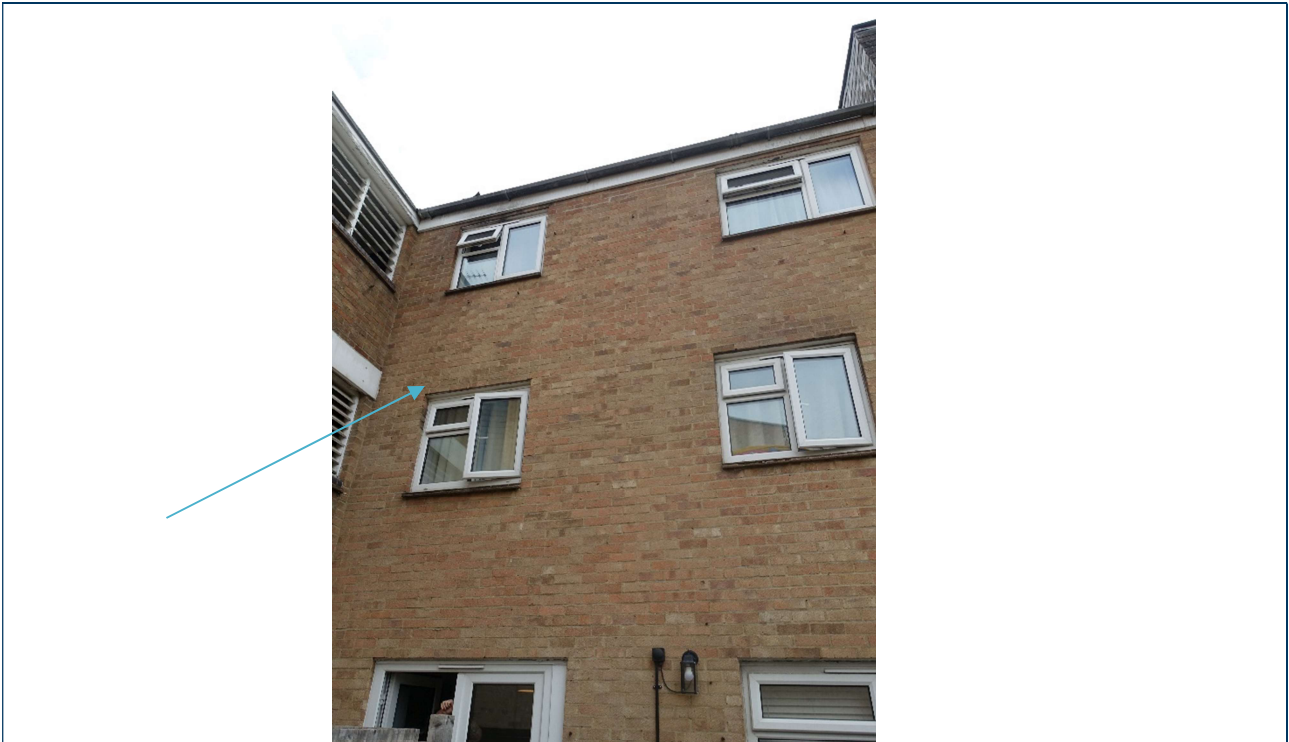
Intrusive investigations were carried out in one location, refer to Photograph No. 15. This investigation confirmed the use of a bitumen based DPC, as a cavity tray, refer to Photograph 16. While this form of bitumen DPC used is considered acceptable, the cavity tray is constructed without a stop end formed, refer to Photograph No. 17.

Photo 15 Rear Elevation (Arrow Indicating Intrusive Inspection Location)

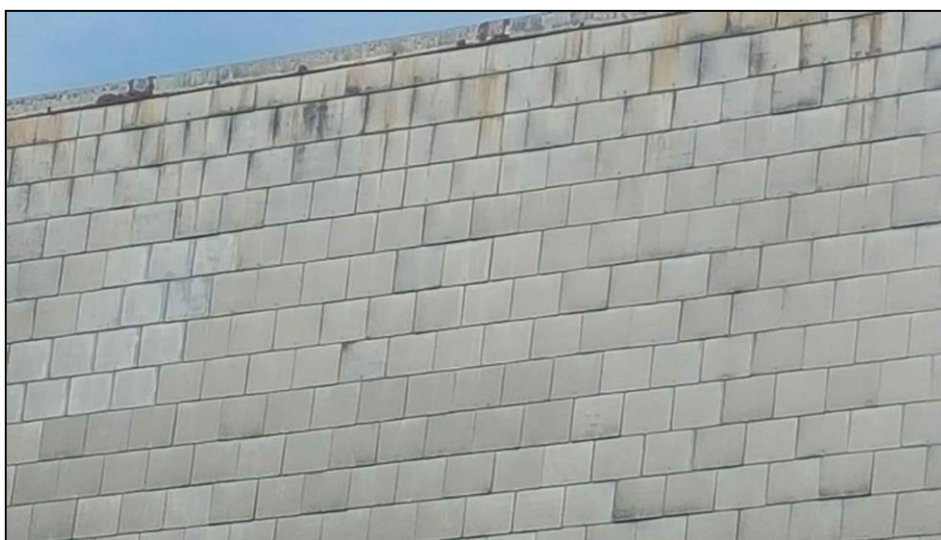
<b>Client:</b>	Harlow Council	<b>Area No:</b>	001
		<b>Floor:</b>	External
<b>Site Address:</b>	Block 4, 1-54 Mercers, Harlow, Essex	<b>Area Description:</b>	External
<b>Building:</b>	219146	<b>Material Description:</b>	Cement based tiles to walls
<b>Building Address:</b>	Flat Block 1-54 Mercers, Harlow, Essex	<b>Survey Report Reference:</b>	PR26735-17457C-0001

<b>Material Risk:</b>	<b>4</b>
Asbestos Type:	1 - Chrysotile
Product Type:	1 - Asbestos composites, decorative finishes, AC
Extent of Damage:	1 - Low damage
Surface Treatment:	1 - Enclosed sprays and lagging, AIB, AC sheets etc
<b>Priority Risk:</b>	<b>1</b>
Normal Occupant Activity:	0 - Rare Disturbance
Likelihood of Disturbance:	1 - Low Likelihood of Disturbance
Human Exposure Potential:	0 - Very Low Human Exposure Potential
Maintenance Activity :	0 - Minor Risk Maintenance Activity

Timescale for Recommendation : 12 months

Recommendation: Manage

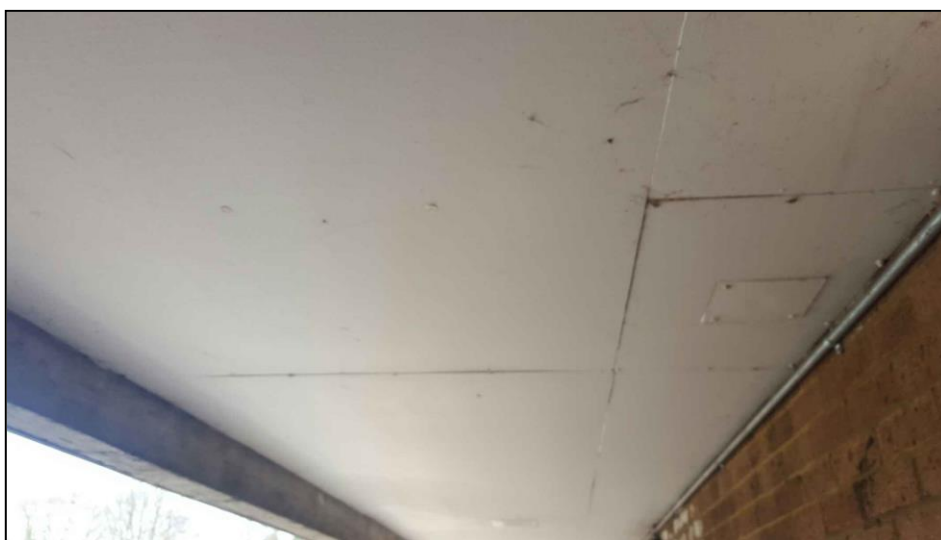
<b>Client:</b>	Harlow Council	<b>Area No:</b>	002
		<b>Floor:</b>	First
<b>Site Address:</b>	Block 4, 1-54 Mercers, Harlow, Essex	<b>Area Description:</b>	First floor access
<b>Building:</b>	219146	<b>Material Description:</b>	Insulation board soffit
<b>Building Address:</b>	Flat Block 1-54 Mercers, Harlow, Essex	<b>Survey Report Reference:</b>	PR26735-17457C-0001

**Material Risk:** 0

Timescale for Recommendation : No action

Recommendation: No further action required
